Handling and Treatment of Sodium-Potassium Alloy (NaK) after the Loss of Key Personnel 19002

Edward P Hart

October 2018

Idaho National Laboratory

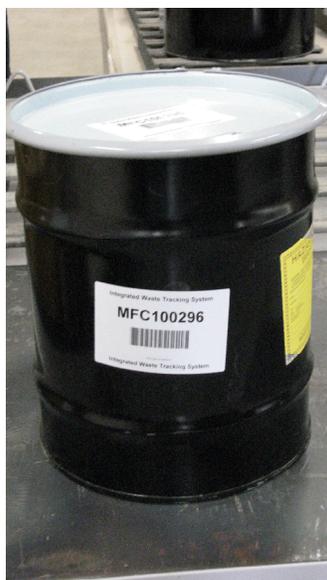
Complex (MFC) research building, located on the Idaho National Laboratory. Workers were transferring 2-3 ounces of NaK from a metal can to a poly bottle so that it could be sent off for characterization. During transfer to the poly container, a reaction of NaK with air was observed in the metal can and poly container. This was an anticipated event. As noted in a critique report the poly bottle also generated heat resulting in a silver dollar sized melted spot on the bottle². In response the two containers were flooded with argon, closed and placed in a safe condition. The workers immediately made notifications and the fire department was deployed as a precautionary measure. The containers were observed overnight with no additional reaction noted. The following day the containers were further packaged into a 10 gal drum and moved to a Resource Conservation and Recovery Act-permitted storage facility. The container was labeled and barcoded with container number MFC100296, see Figure 1. The container was transported to the storage location via a drum dolly on foot for approximately two blocks from where it was generated. According to one employee the trip took several hours because the drum heated up significantly at the slightest bump. Long cool down periods were required between short moves.

Figure 1. 10-gal container containing poly bottle with 2-3 ounces of NaK.

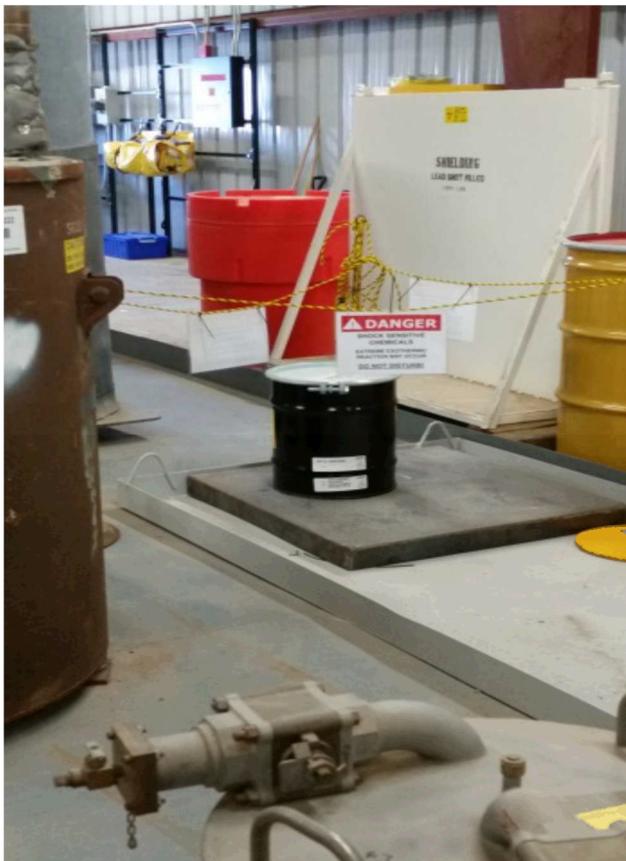
As a result of the assessment, an operability review by MFC Environmental, Safety, and Health to ensure adequacy and compliance with applicable requirements was performed. This review concluded that the container was acceptable for storage and that the container was properly labeled and inspected per the permit. Based on review by Industrial Safety and Health several controls were put in place which included, limiting access to the locked building, isolating the container by roping and posting as “shock sensitive”, see Figure 2, and suspending forklift operations pending further expert analysis.

Figure 2. 10-gal container containing poly bottle with 2-3 ounces of NaK

The report concluded that based on CEI's opinion the NaK container could be safely inspected. The reacted NaK material was likely not shock sensitive, however, it was recommended that the drum should continue to be stored as such until a proper inspection could be made and a treatment plan developed that assumes the material was shock sensitive. It also concluded that the drum could be safely opened and inspected after the development and approval of an inspection plan.

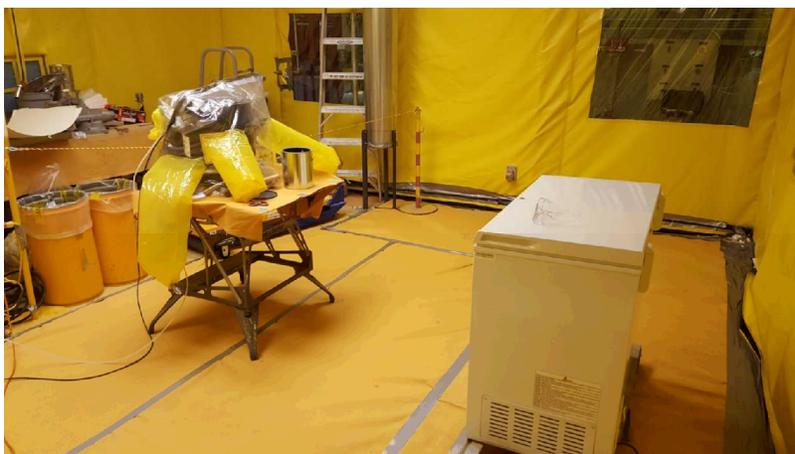
Figure 6. Showing freezer and glovebag with container

After completion of training MFC personnel developed a detailed inspection plan. The plan considered all associated risks in order to open and visually inspect the container. The inspection plan allowed for the container to be handled, transferred, opened, and inspected. The container was placed in a freezer at the storage location to ensure it would be maintained below its melting point in order to provide a more stable state for transferring the container to a separate inspection and treatment location elsewhere at MFC. After 24 hours the freezer was transferred via a forklift from the permitted storage facility to a facility where treatment of sodium and NaK is permitted. The freezer was brought into a large area enclosure tent where the container was removed from the freezer. The container was then placed into a glovebag that was sealed and inerted with argon, see Figure 6. The container was opened and the contents of the drum were inspected³. A small 60 ml poly bottle with a small amount of NaK was found which appeared to be approximately 2-3 ounces which coincides with what was indicated in the critique report. The poly bottle had signs of burns as noted in the critique report as well. Personnel also looked for oils or evidence of superoxides. No evidence of oils or superoxides were noted. The NaK container was then removed from the glovebag and transferred to a RCRA-permitted water wash vessel where the NaK was reacted. Due to the small amount of NaK, minimal reaction was noted.

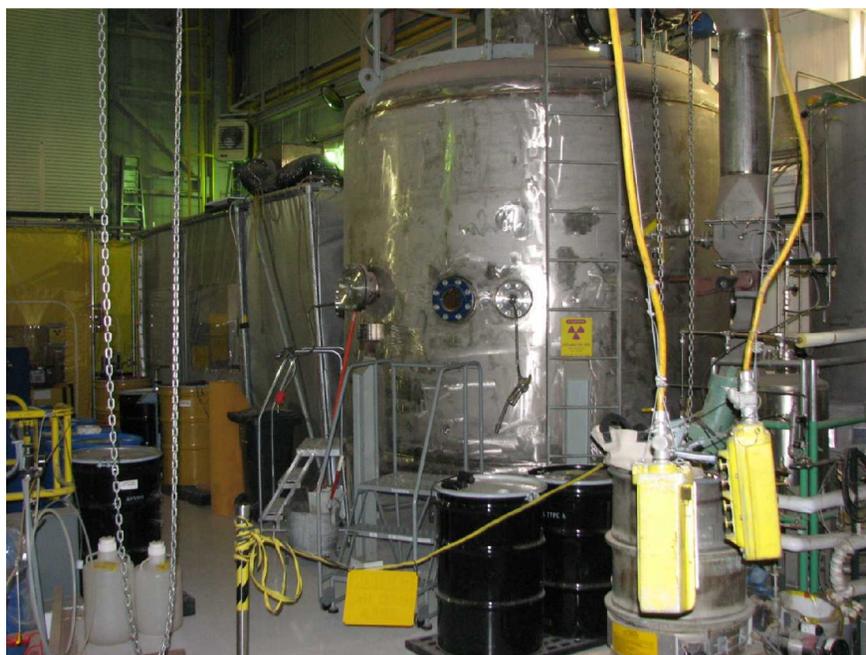
The water wash vessel is used to deactivate ignitable and reactive hazardous waste and has an operating limit of 5 pounds of NaK or sodium. The water wash vessel has been used since 1981 and is a vertical cylindrical tank. It is approximately 10 ft in diameter and 12 ft high. The water wash vessel has a personnel and equipment access door on one side to allow for the placement of materials and the removal of any reactants. Removable floor grating is installed near the bottom of the tank to provide a working platform for personnel and equipment. There are four penetrations for spray lances to discharge water in a controlled manner and three viewing windows to observe the deactivation operations. See Figure 7 showing a picture of the water wash vessel.
